Drainage Report

2023 Street and Utility Improvements

City of Montgomery, MN May 31, 2022

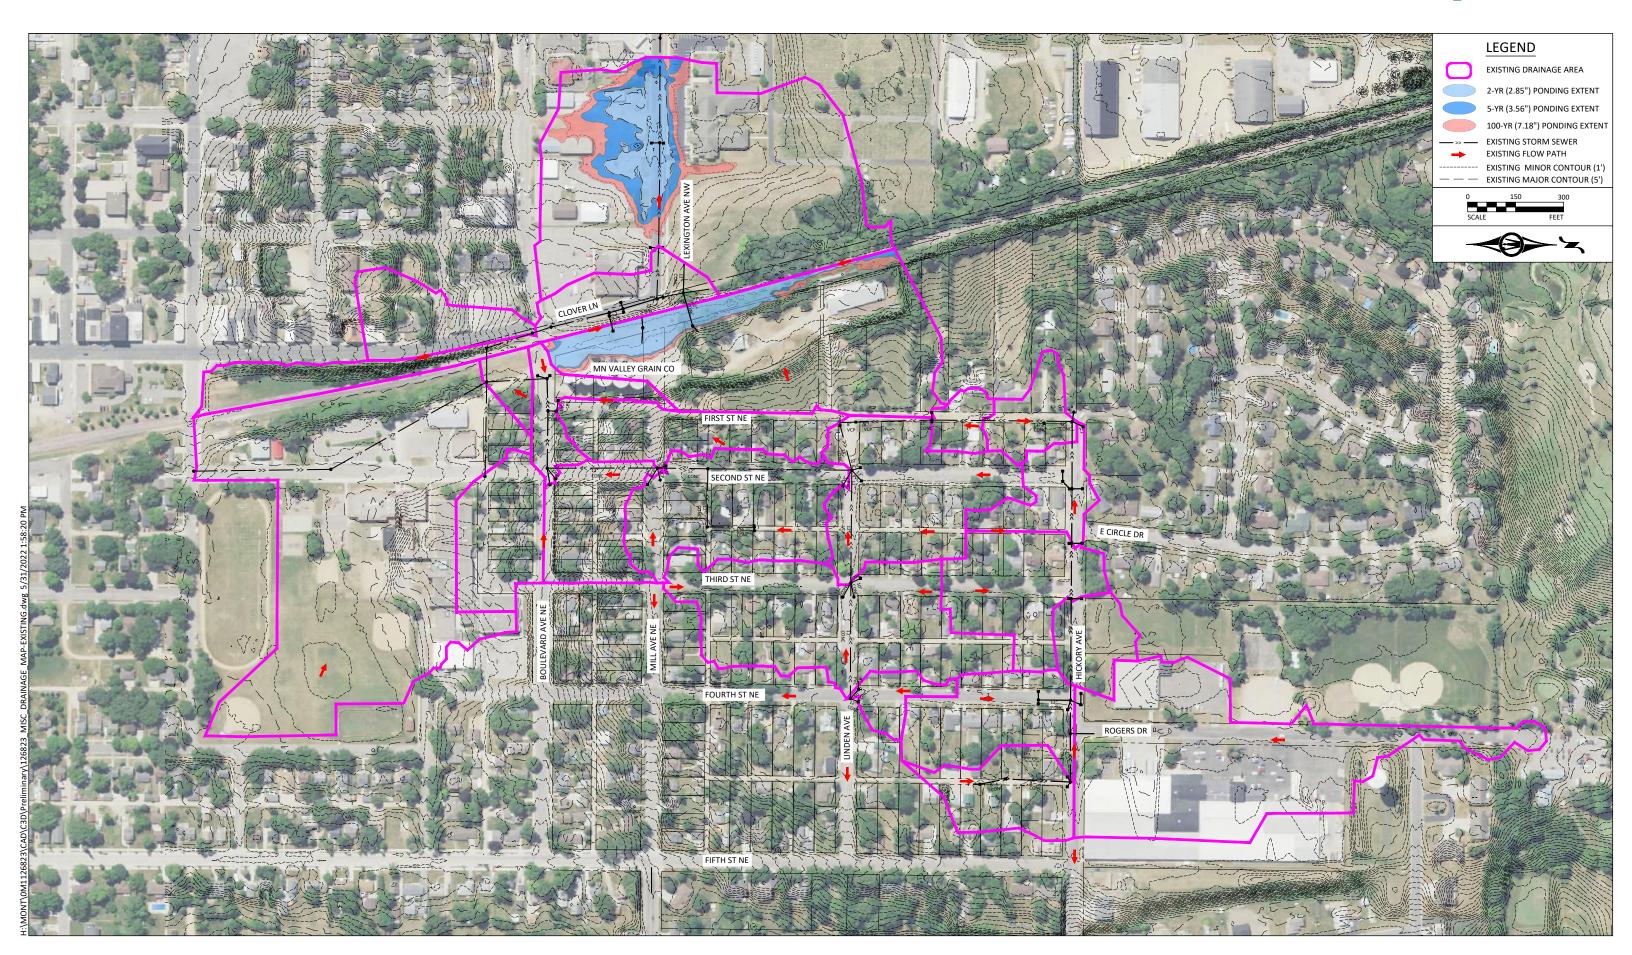
Figure 1: Existing Drainage Conditions May 2022

Figure 1: Existing Drainage Conditions can be found in Appendix A and shows the existing storm sewer layout, drainage areas, flow directions and ponding extents at the low point on Lexington Avenue and the MN Valley Grain Co site.

The proposed project's outfall is the existing 30" storm sewer pipe running down Lexington Avenue. The low points in this street and on the MN Valley Grain Co site experience significant ponding today (refer to Figure 1 in Appendix A for ponding extents). Improving the upstream stormwater management system will only exacerbate this problem unless collected runoff is slowed down in a detention basin before discharging to the existing storm sewer. A stormwater detention basin is proposed on the empty City parcel located east of the Union Pacific railroad and north of Mill Avenue. This detention basin has been designed to provide 2.5 acre-feet of storage and will reduce both proposed discharge rates to the downstream system and ponding at the low points of concern compared to the existing conditions. The proposed detention basin will allow for the upstream storm sewer system to be upsized while maintaining a reduced outlet size. Additionally, the detention basin will intercept excess runoff that today flows overland down 1st Street NE and spills down Mill Avenue NE reducing ponding on the MN Valley Grain Co site. As part of the railroad detention basin, a new storm sewer pipe crossing under the railroad tracks will be constructed and connect back into the existing storm sewer line on Lexington Avenue. This railroad crossing will require coordination and permitting through Union Pacific. Union Pacific's engineering designing requirements have been included in Appendix C for reference.

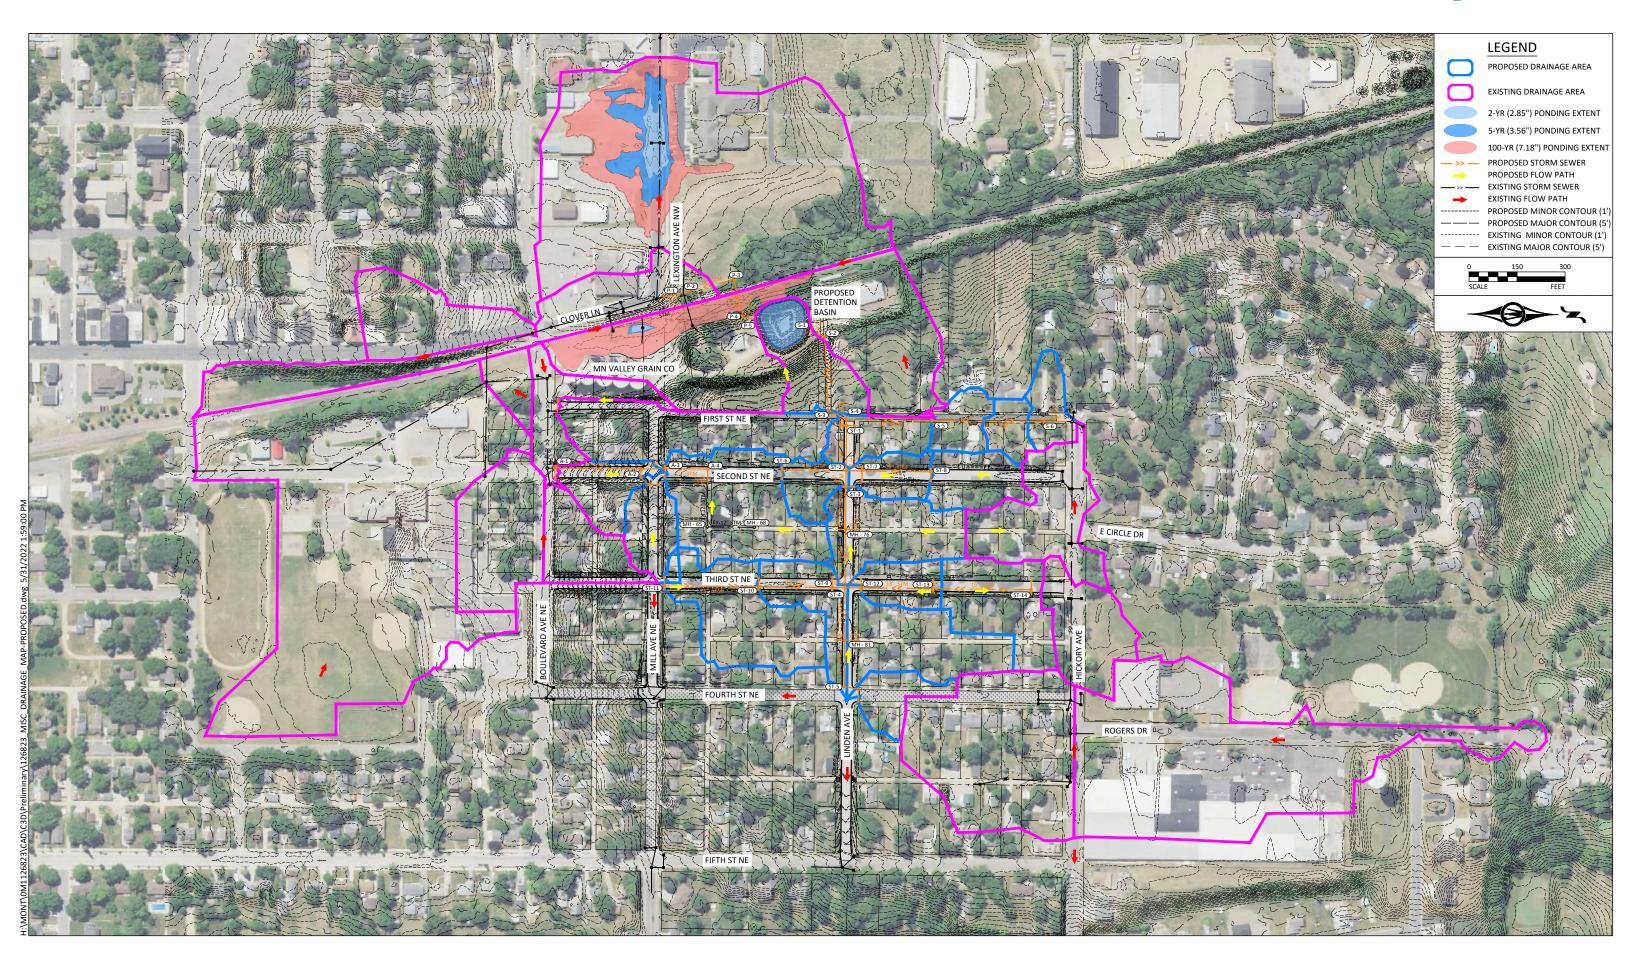
Figure 2: Proposed Drainage Conditions May 2022

Figure 2: Proposed Drainage Conditions can be found in Appendix A and shows the proposed storm sewer layout and sizing, drainage areas, flow directions and ponding extents at the low point on Lexington Avenue and the MN Valley Grain Co site.

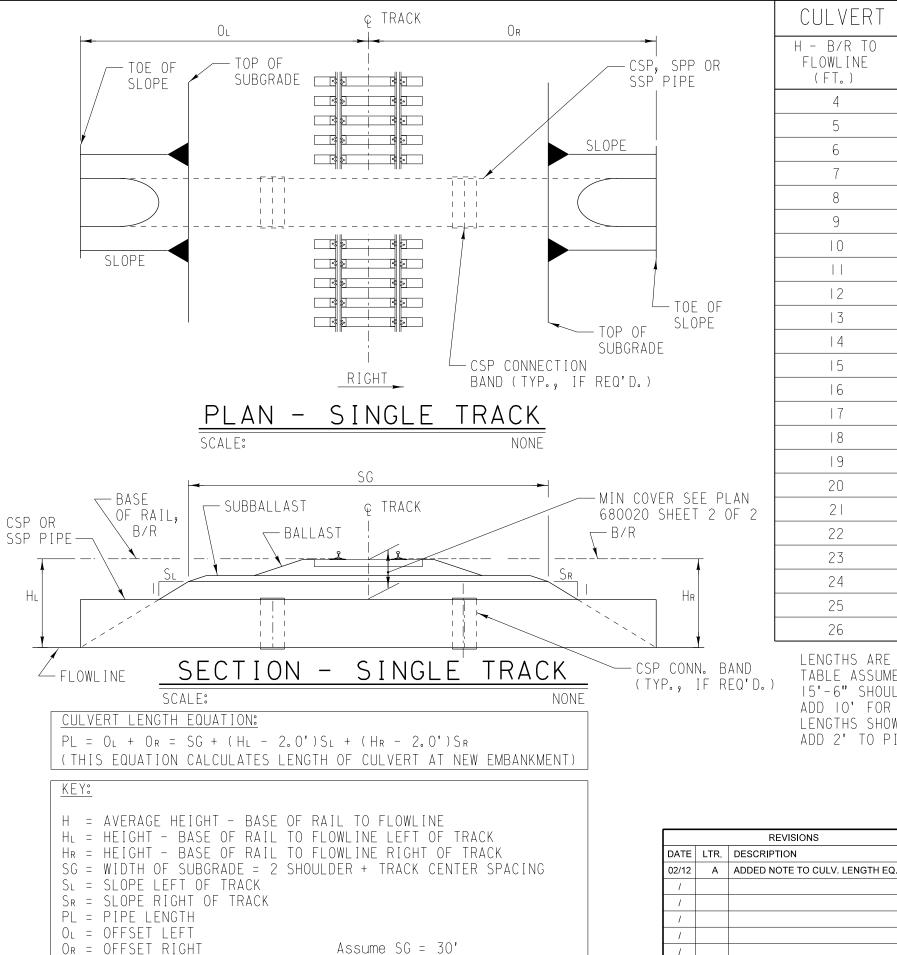
LENGTHS ARE ROUNDED TO THE NEAREST EVEN NUMBER OF FEET TABLE ASSUMES 15'-O" SHOULDER FOR SINGLE TRACK AND 13' CENTERS, 15'-6" SHOULDER FOR 20' TRACK CENTERS, ADD IO' FOR EACH ACCESS ROAD, LENGTHS SHOWN ARE FOR STANDARD CROSS SECTIONS FOR TANGENT TRACK, ADD 2' TO PIPE LENGTH (TO OUTSIDE OF CURVE) IF SUPER ELEVATION IS 2" OR GREATER.
